Fire Origin & Cause Report

EFI Global File No.: 019.02004
October 11, 2021

Residential Structure Fire

Ottercreek Group LLC
5281 Locust Hill Lane
Dublin, Ohio 43017

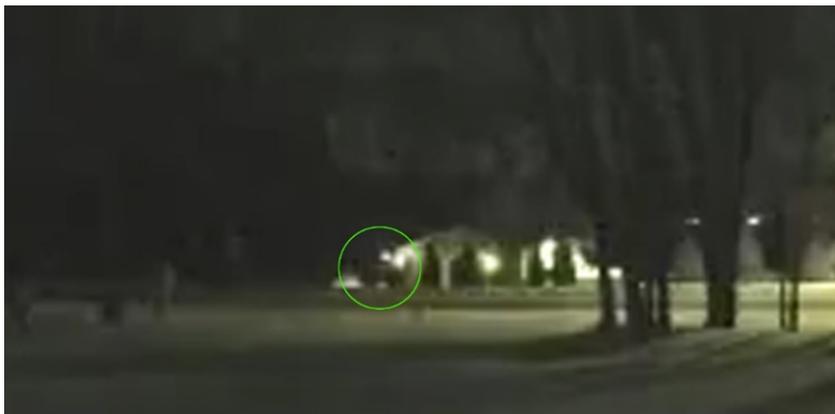
Figure 2: Car in driveway 5300 Locust Hill

Ring Video 1, according to the Meta Data, was created on February 9, 2021 at 11:28p.m. At the immediate beginning of the video a rear light that shuts off is seen at 5300 Locust Hill Lane and there is a car in the driveway pulled up to the house. A flash can be seen mid-way up a first-floor window that appears to be from the rear interior towards the center of the structure at 5281 Locust Hill that rapidly erupts to fire showing through the visible first floor windows.

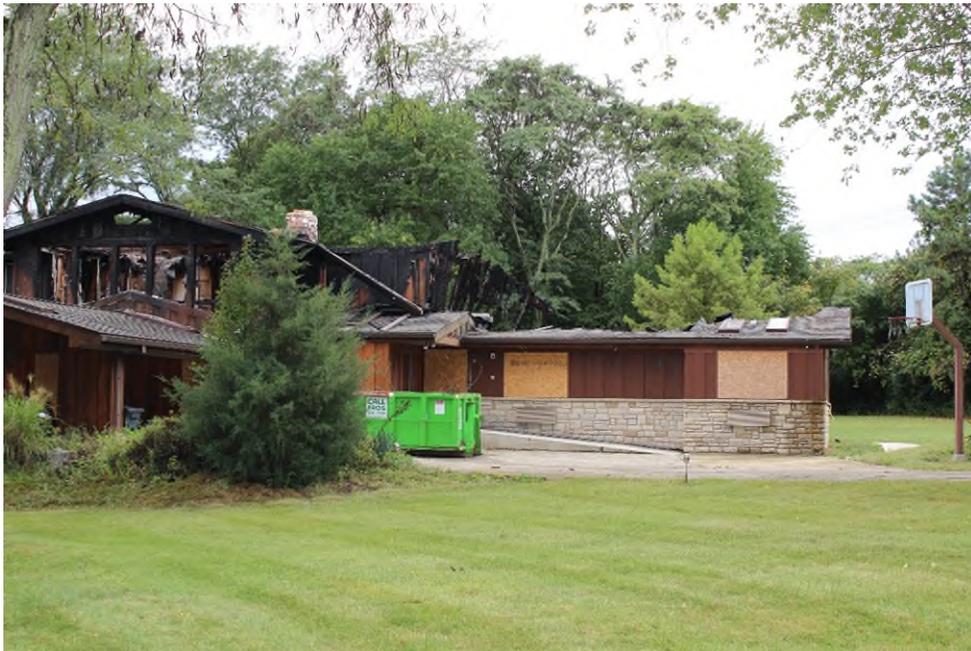
Photo 1: Front, west end of structure.

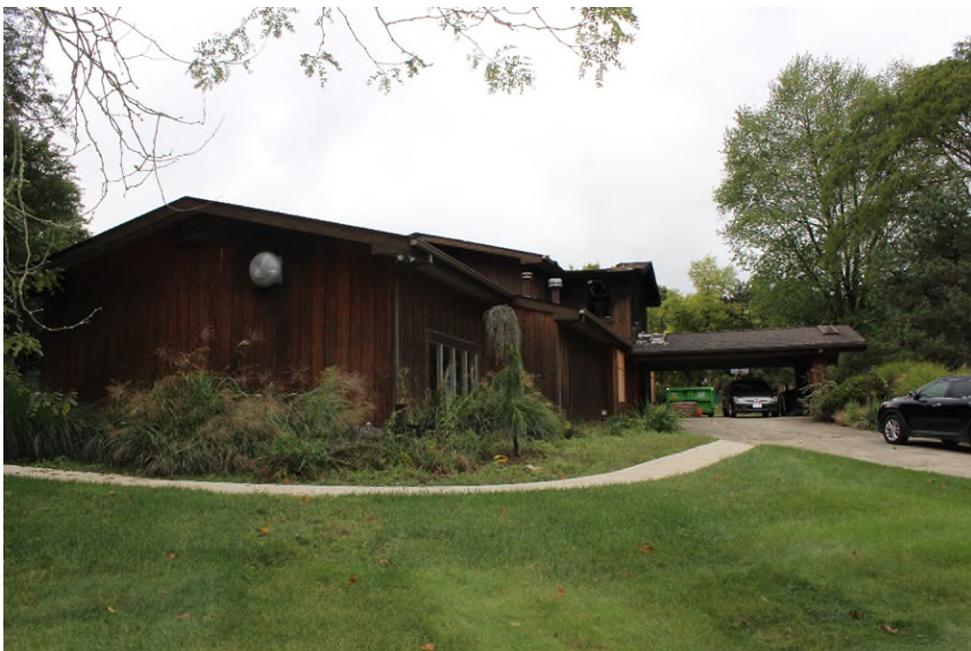
Photo 2: Front and east end of structure.

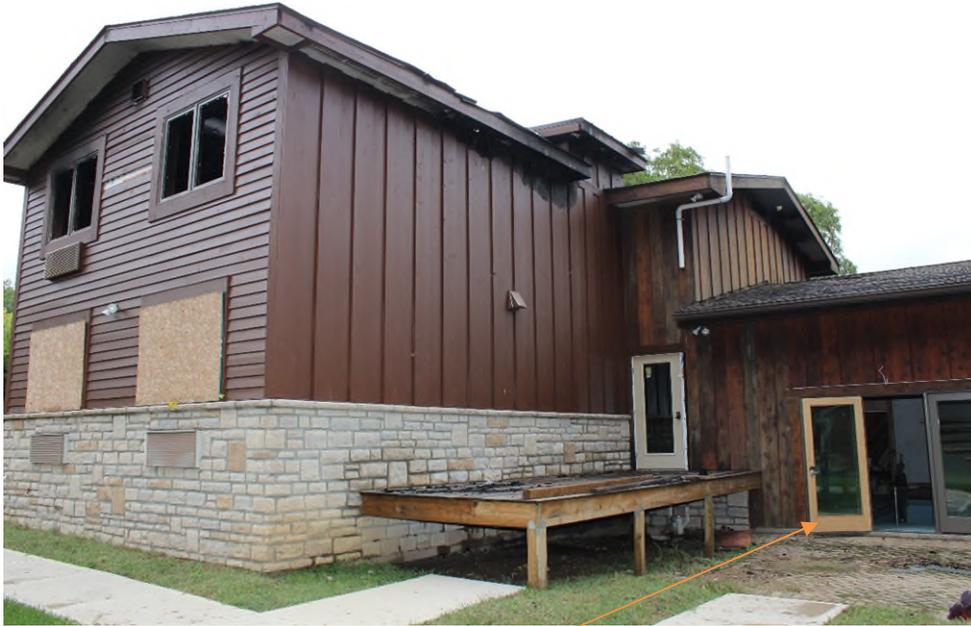
Photo 3: Rear center. Pool room door.

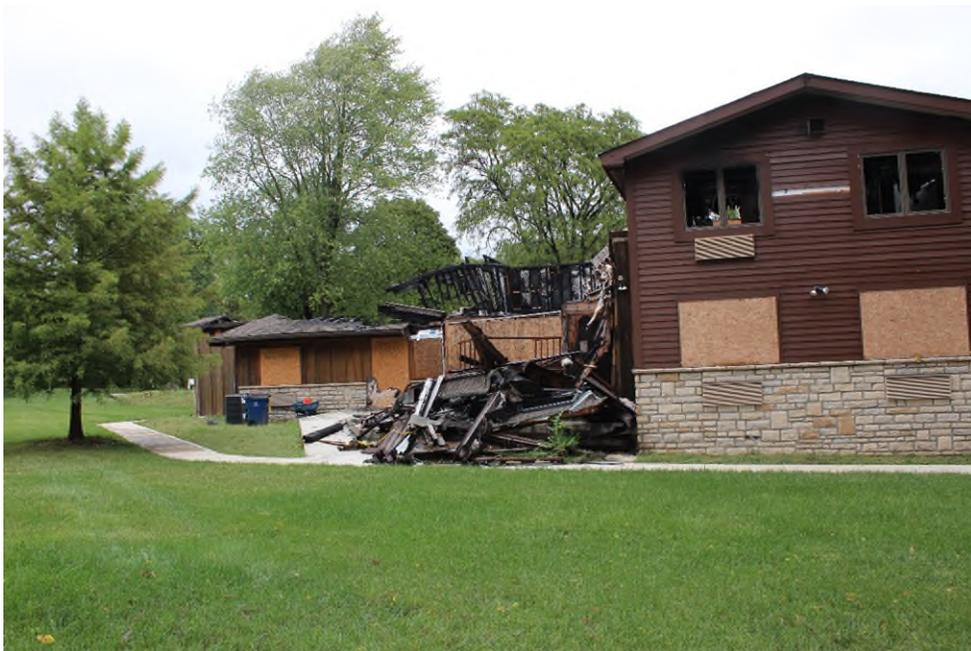
Photo 3: Rear west end.

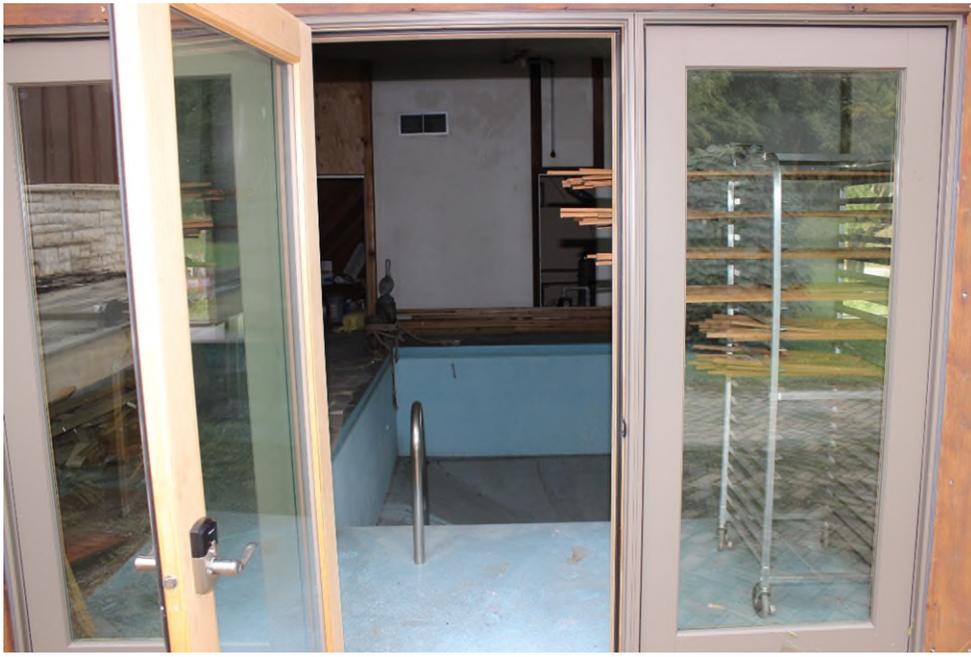
Photo 4: Pool room door, no evidence of forced entry.

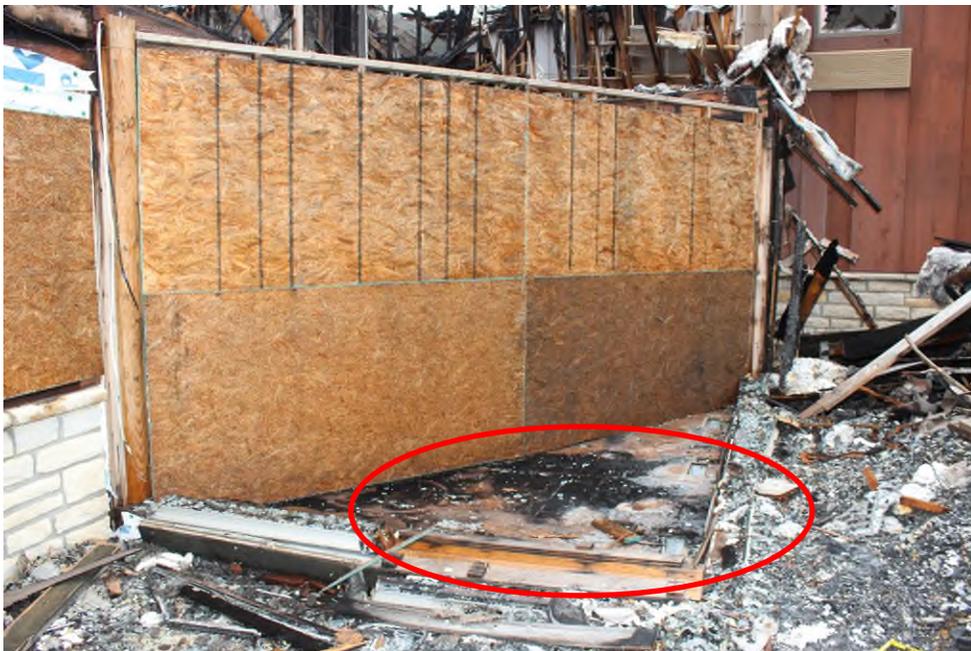
Clean glass found during the examinations is evidence that the glass was broken prior to the fire’s ignition. Had the glass been broken as a result of the fire or suppression activities smoke and soot accumulations would be present on the interior facing side.

Photo 5: Temporary wall across Great Room. Start of irregular fire pattern and location of clean broken glass.

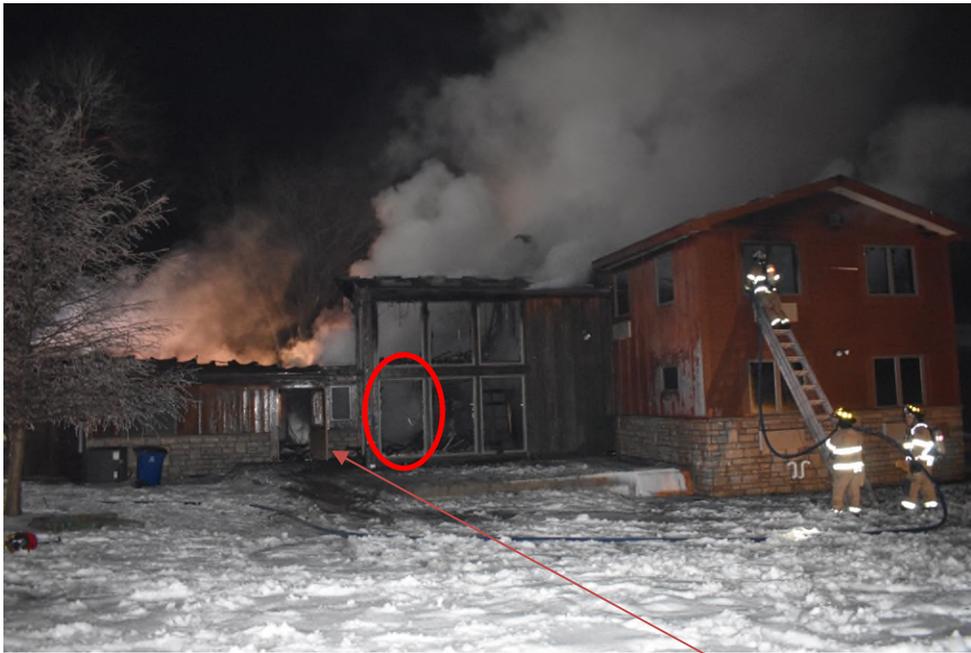
Investigator Hamilton stated that a gas can was found near the west end of the curtain wall. They believed the west window had been broken as clean glass was found at the base. During the EFI review of the Washington Township scene photos the west end window showed a different breakage pattern compared to the adjacent windows. Clean glass was found on the floor and collected as evidence during the EFI examination. The door located to the west of the curtain wall had evidence of forced entry and was found to be open in the fire department photos. Investigator Hamilton did not recall any mention of the door being forced. It is unknown if this door had been forced prior to or after the fire department’s arrival. Investigator Hamilton stated the door to the east to the pool room was able to be pushed open and was not latched. During the EFI examination this door was secured with a battery-operated electronic lock that automatically locked and functioned properly. Scott Hamilton confirmed it was the same lock on the door. The east end of the structure had the least amount of damage, and the pool room only had light smoke damage. Either door could have provided a route of egress during the fire.

Photo 6: Fire Department Photo. Great room curtain wall prior to collapse/removal. Possible window of entry circled. Door to left forced open by unknown.

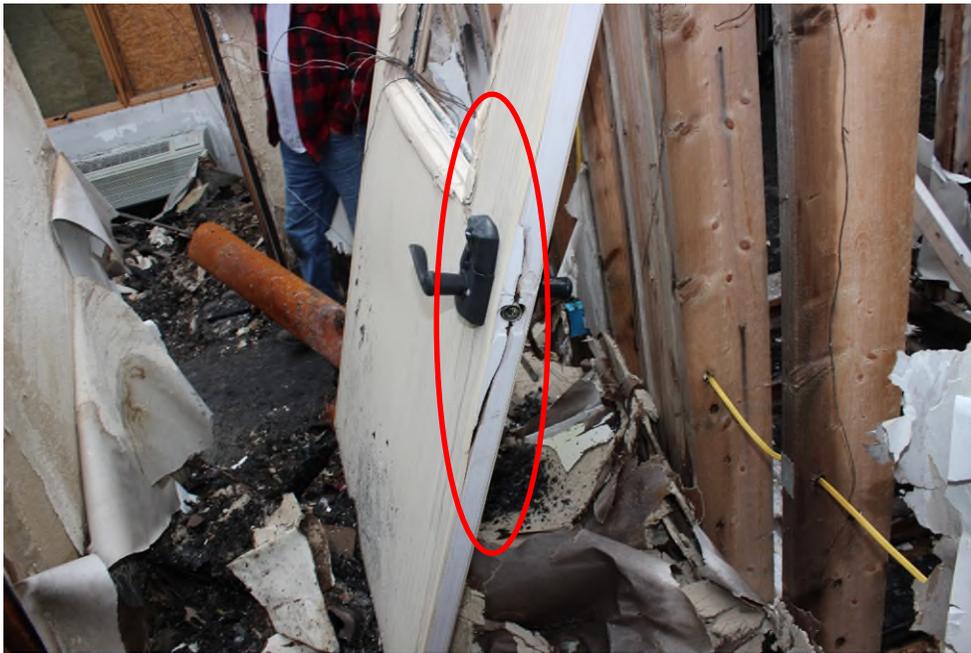
Photo 7: Forced entry damage to rear door.

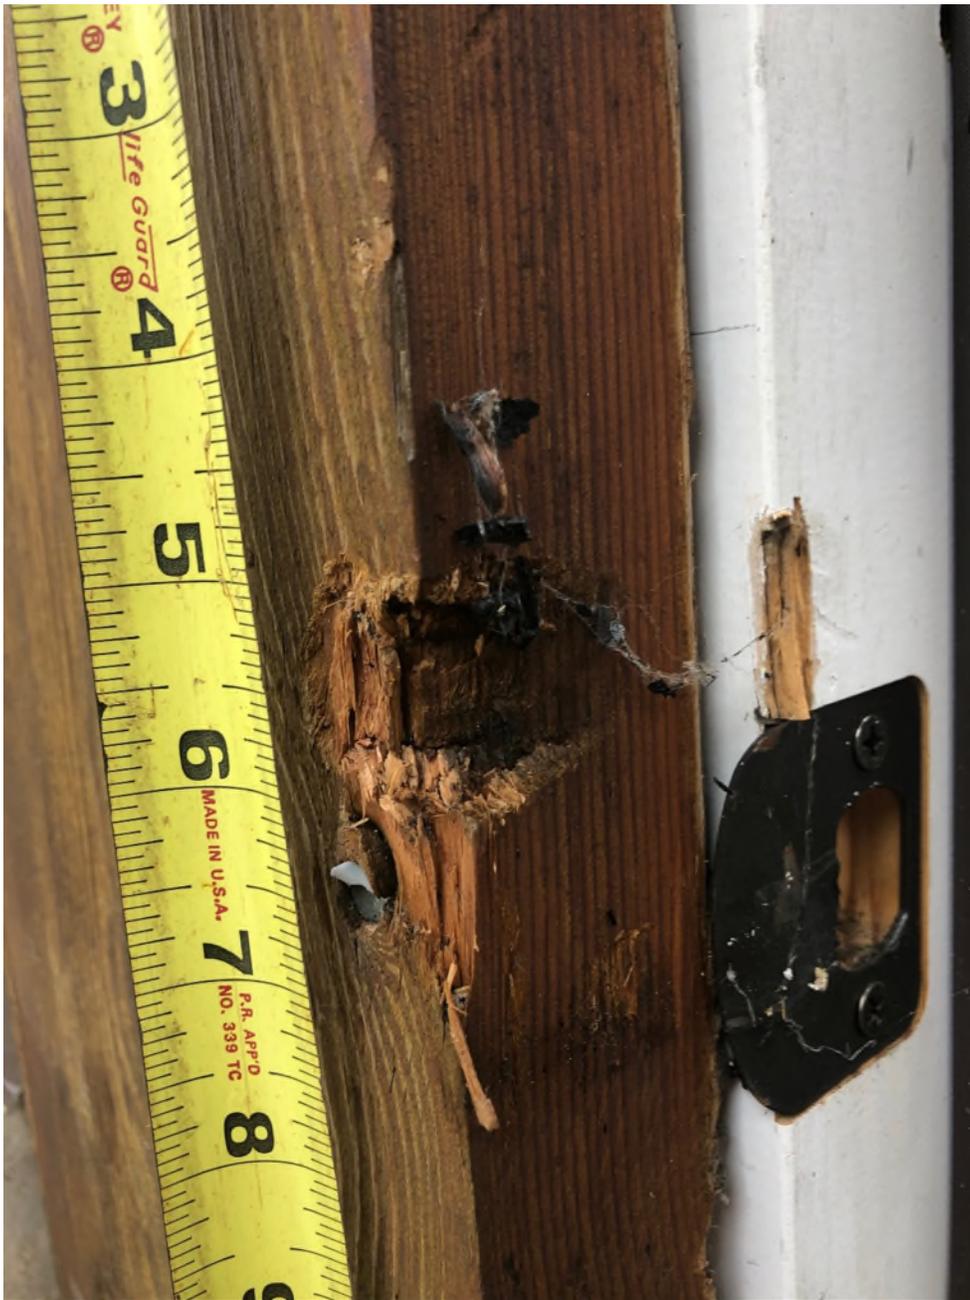
Photo 8: Rear door forcible entry damage, tool mark.

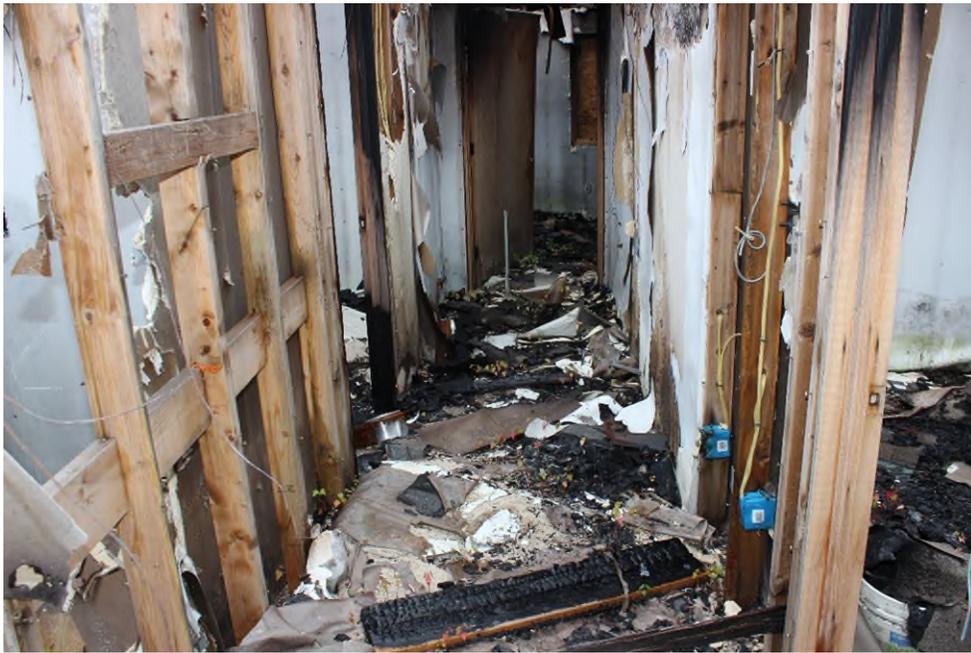
Photo 9: West hallway before debris removal.

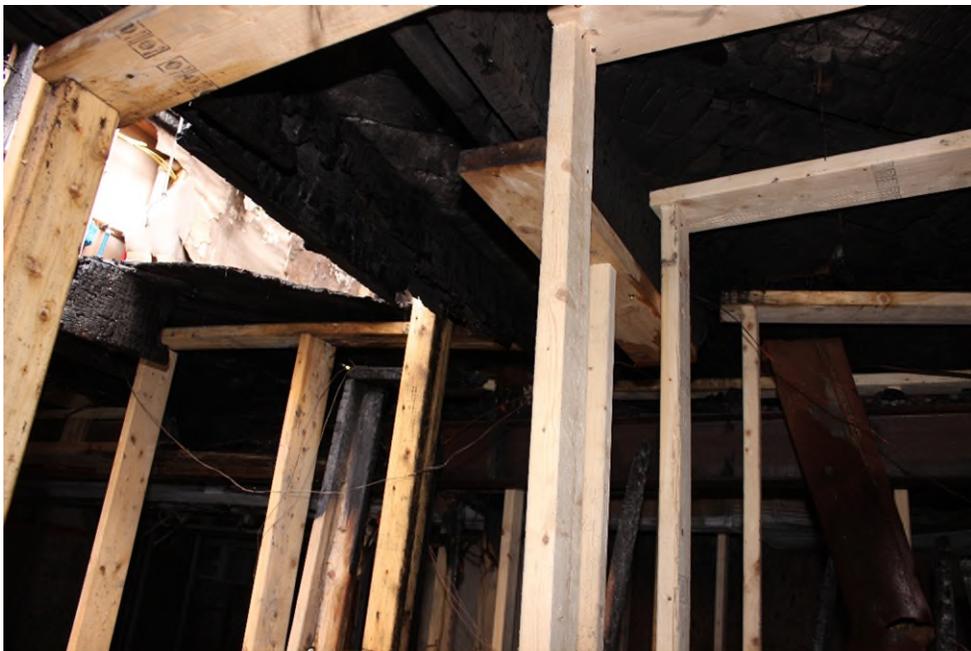
Photo 10: Example of shoring supporting damaged floor under Great Room.

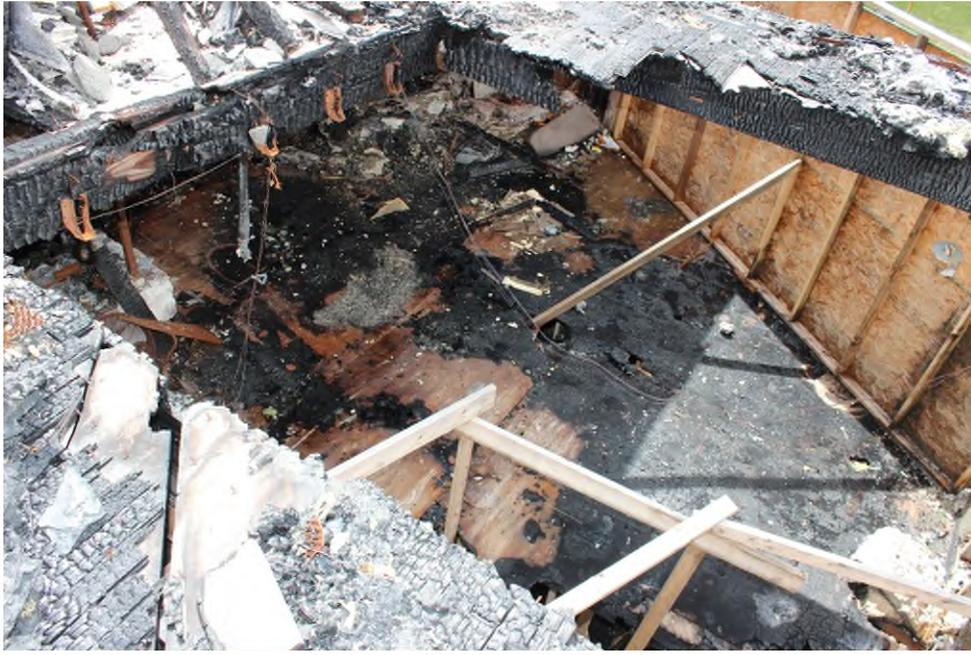
The fire originated at the irregular shaped fire pattern located on the great room sub flooring and extended along the pattern throughout the first floor. As smoke and hot gasses built up and ignited, the fire extended to the second floor, and first floor attic areas. This sequence coincides with the footage contained in Ring Video’s 3 and 4. In comparing the Ring Video times and the fire report times the fire burned undetected for approximately forty-nine minutes.

Photo 11: Irregular pattern on Great room floor taken from second floor.

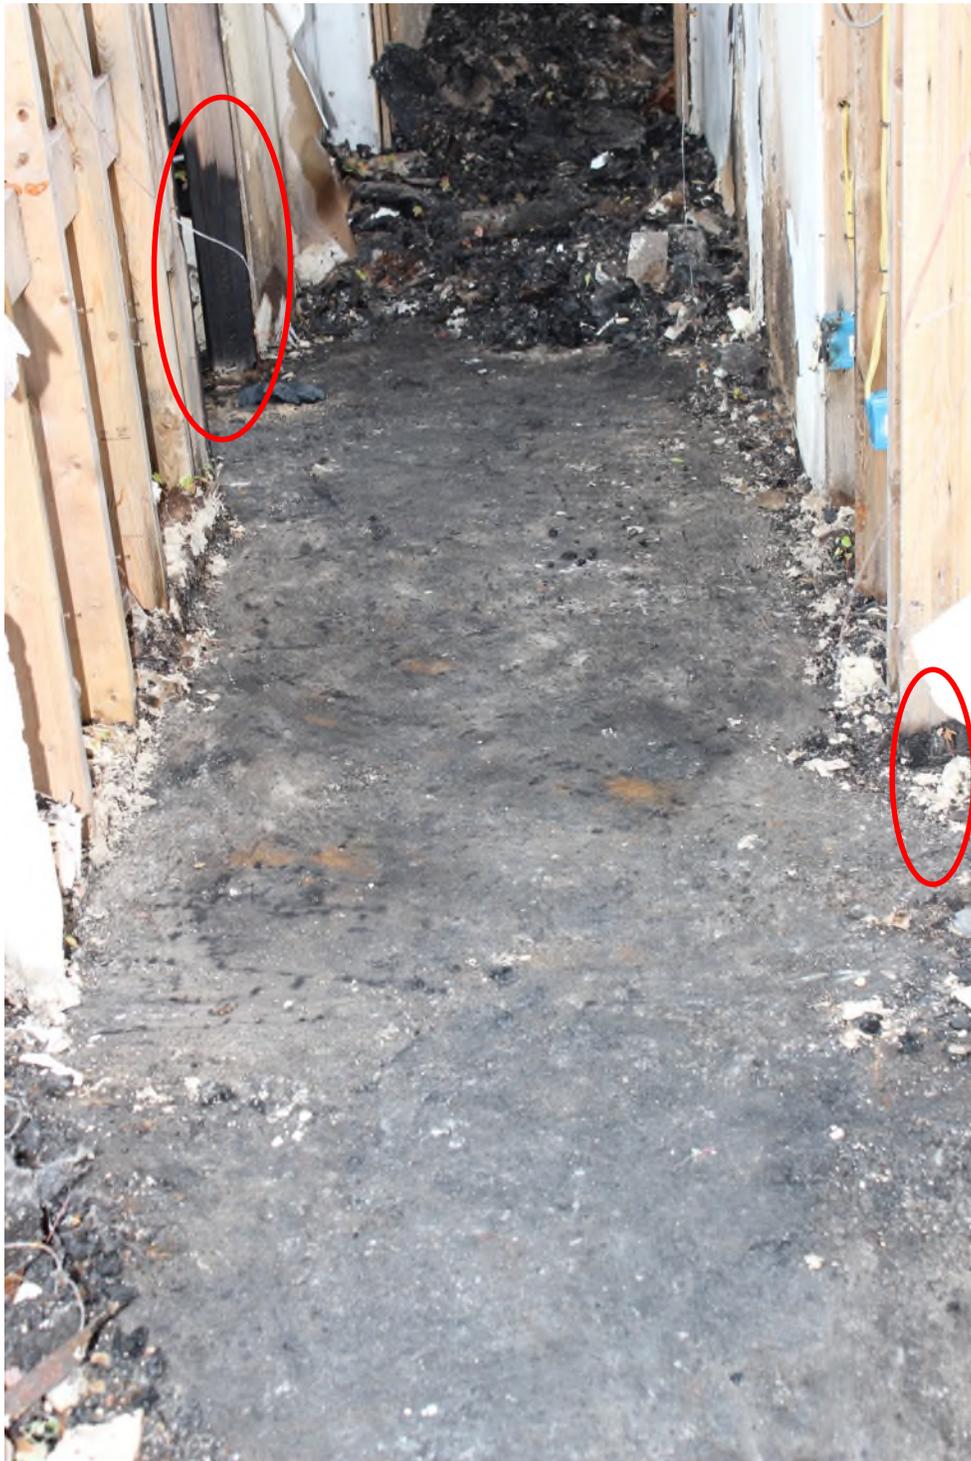
Debris removal was completed, and an irregular fire pattern was found on the floor that was an extension of the same pattern found in the great room. The remaining rooms had moderate soot deposition and a consumed roof; all damage decreased in intensity away from the great room area. The hole to the south leading to a rear exterior door was also covered in debris and the exterior door was found on the floor. Upon examination of the door and door frame both exhibited evidence of forced entry around the locking mechanism.

Photo 12: West hallway after debris removal, exposing irregular fire pattern and floor level burning.
