Fire Origin & Cause Report

EFI Global File No.: 019.02004
October 11, 2021

Residential Structure Fire

Ottercreek Group LLC
5281 Locust Hill Lane
Dublin, Ohio 43017

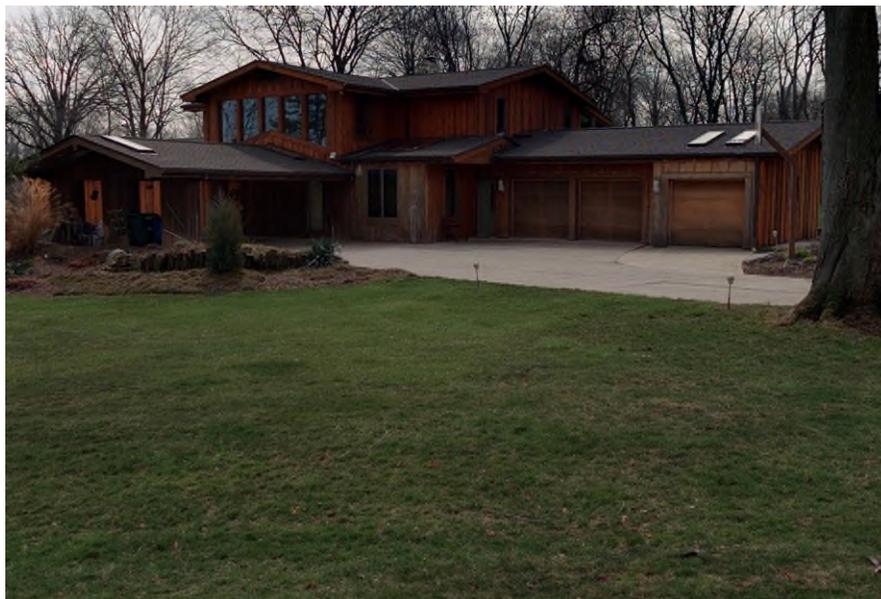
Figure 1: 2017 Photo from Franklin County Records.

The subject property had been undergoing a remodeling project that commenced in March of 2020. The structure was being converted from a single-family dwelling to a residential assisted care home for seniors. **Figure 1** depicts a 2017 photograph of the general exterior of the property pre-fire.
